4. TITLE (and Subtitle) WILLOW CREEK DAM SPILLWAY AND STILLING BASIN AT HEPPNER, OREGON Hydraulic Model Investigation		5. TYPE OF REPORT & PERIOD COVERED

WILLOW CREEK DAM
SPILLWAY AND STILLING BASIN
AT
HEPPNER, OREGON

Hydraulic Model Investigations

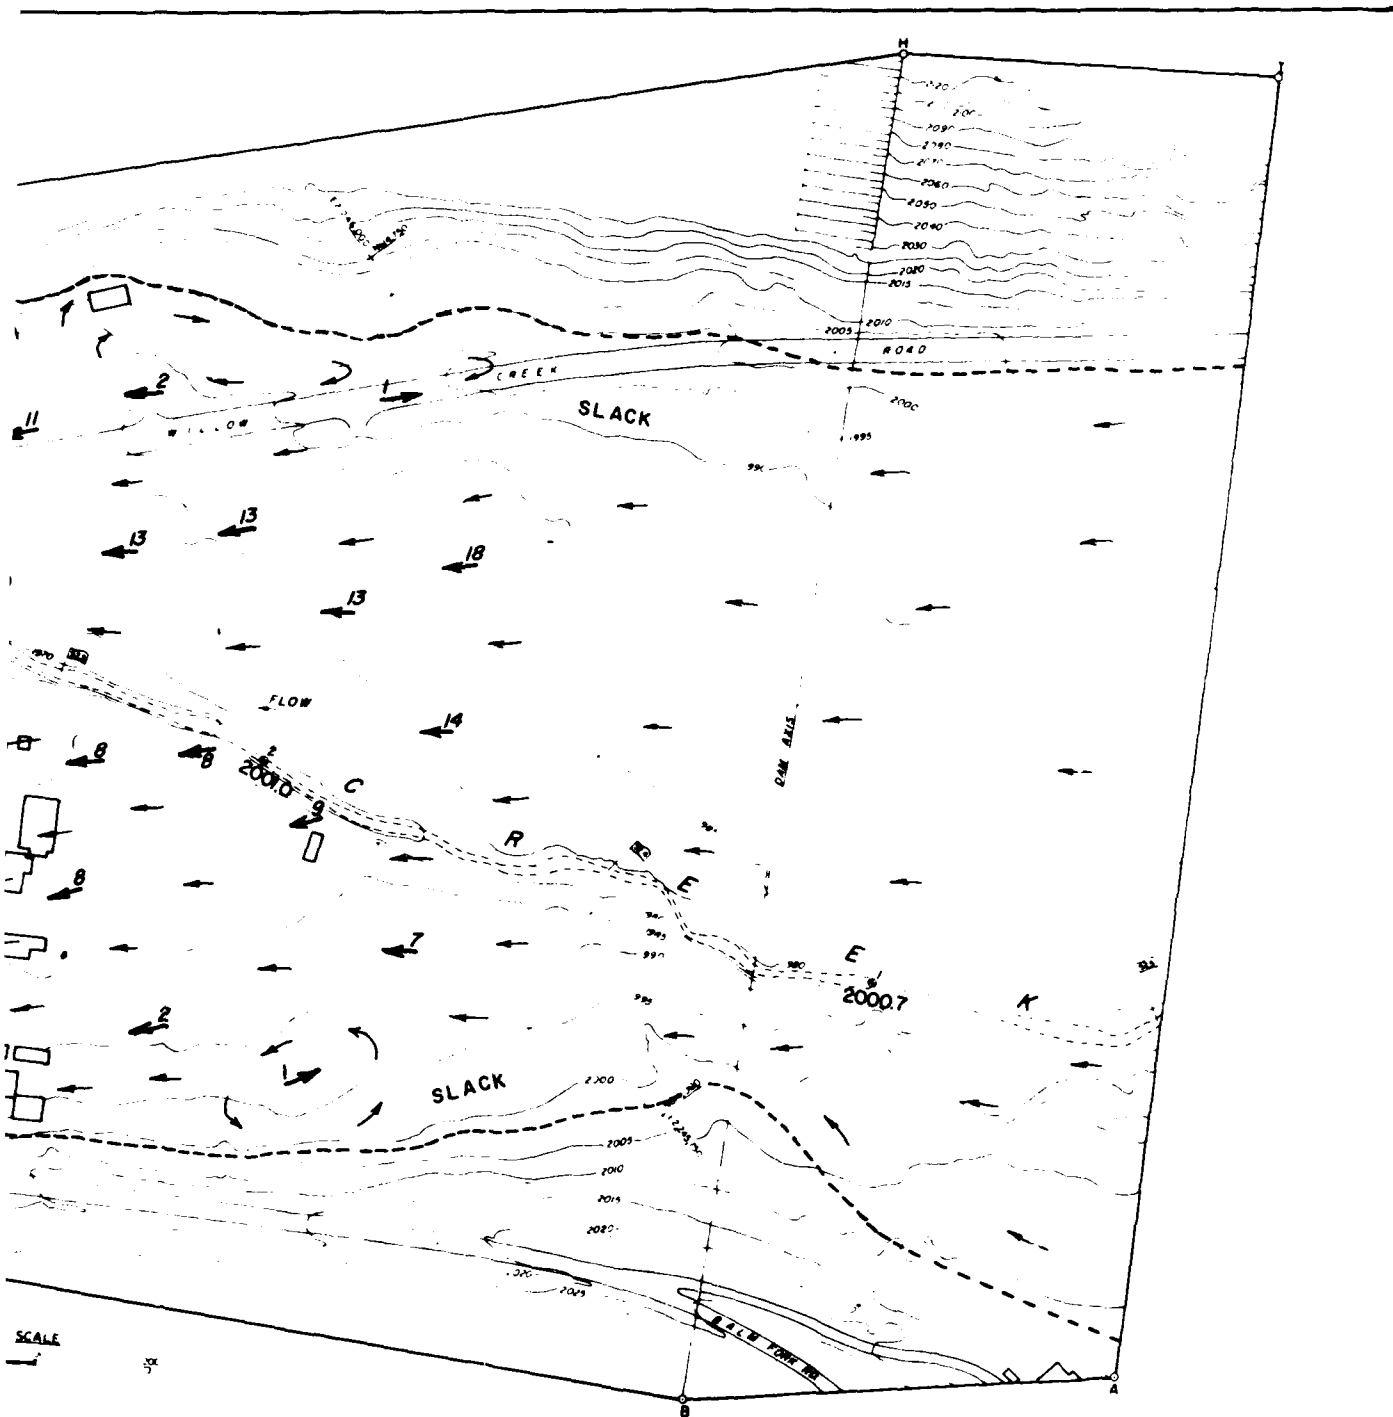
PLATE 3

FLOW CONDITIONS
UNREGULATED SPILLWAY DESIGN FLOOD
DISCHARGE 107 000 CFS

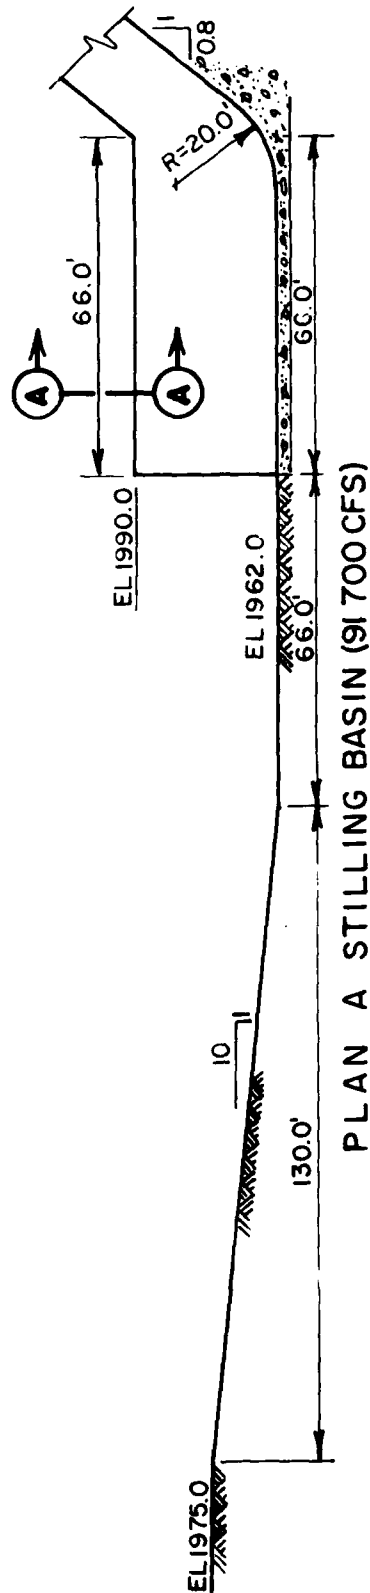
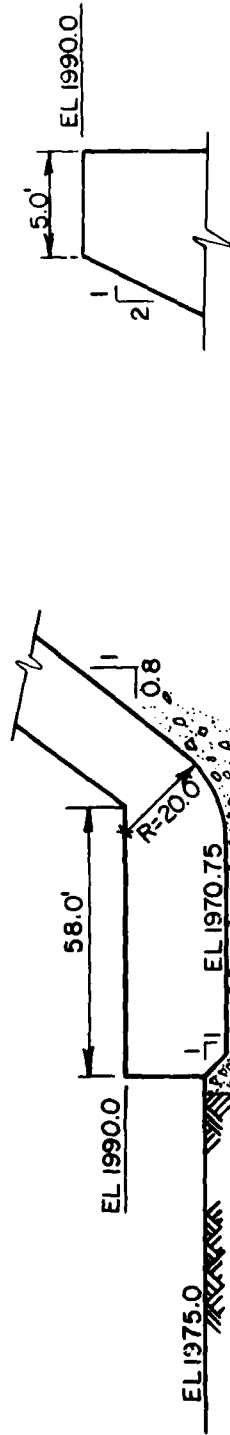
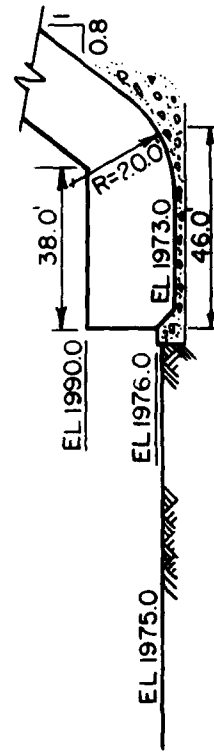
WALL SECTION A-A

PLAN B STILLING BASIN (11700 CFS)

PLAN DESIGNATION
STILLING BASIN PLAN A TO C

12. The Plan B basin (plate 4), designed for the regulated thunderstorm SPF 11,700 cfs, was 46 feet long with a floor elevation of 1973.0 feet and a 3-foot-high sloping end sill. Tests were made for discharges of 11,700, 15,000, 45,000, and 91,700 cfs.

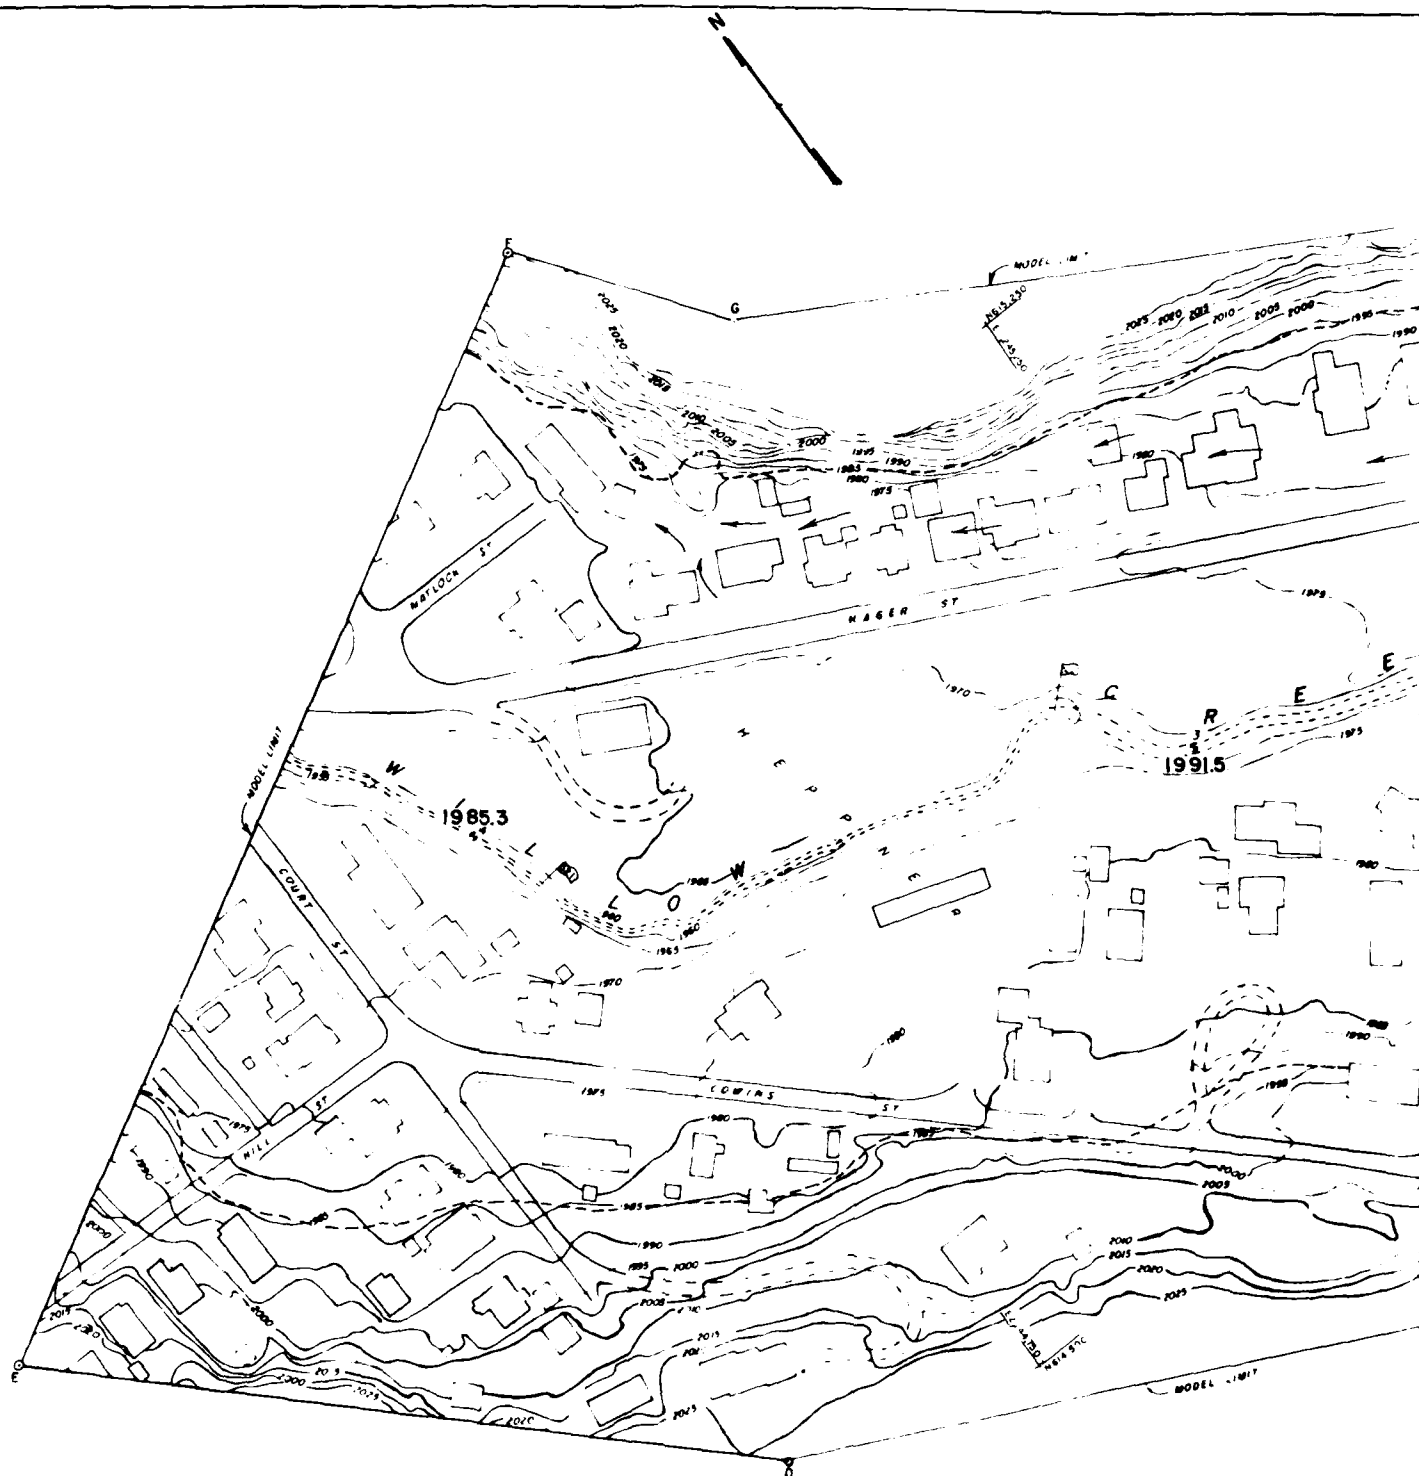
PLATE 5

FLOW
REGULATED
DISCHARGE
STILLING BASIN
AND 4-FT-HIGH

STILLING BASIN FOR 91 700 CFS WITH SCOUR
 AND 4-FT-HIGH END SILL INSTALLED

11. The addition of a 4-foot-high sloping end sill at the downstream end of the concrete apron was sufficient to contain the hydraulic jump within the basin apron and runout slope for all discharges up to 91,700 cfs (photographs 8 and 9). At the design discharge and with the end sill added, velocities on the excavated runout slope were 15 fps and velocities over the simulated scoured area downstream from the runout and near Alfalfa Street were 12-13 fps (plate 5).

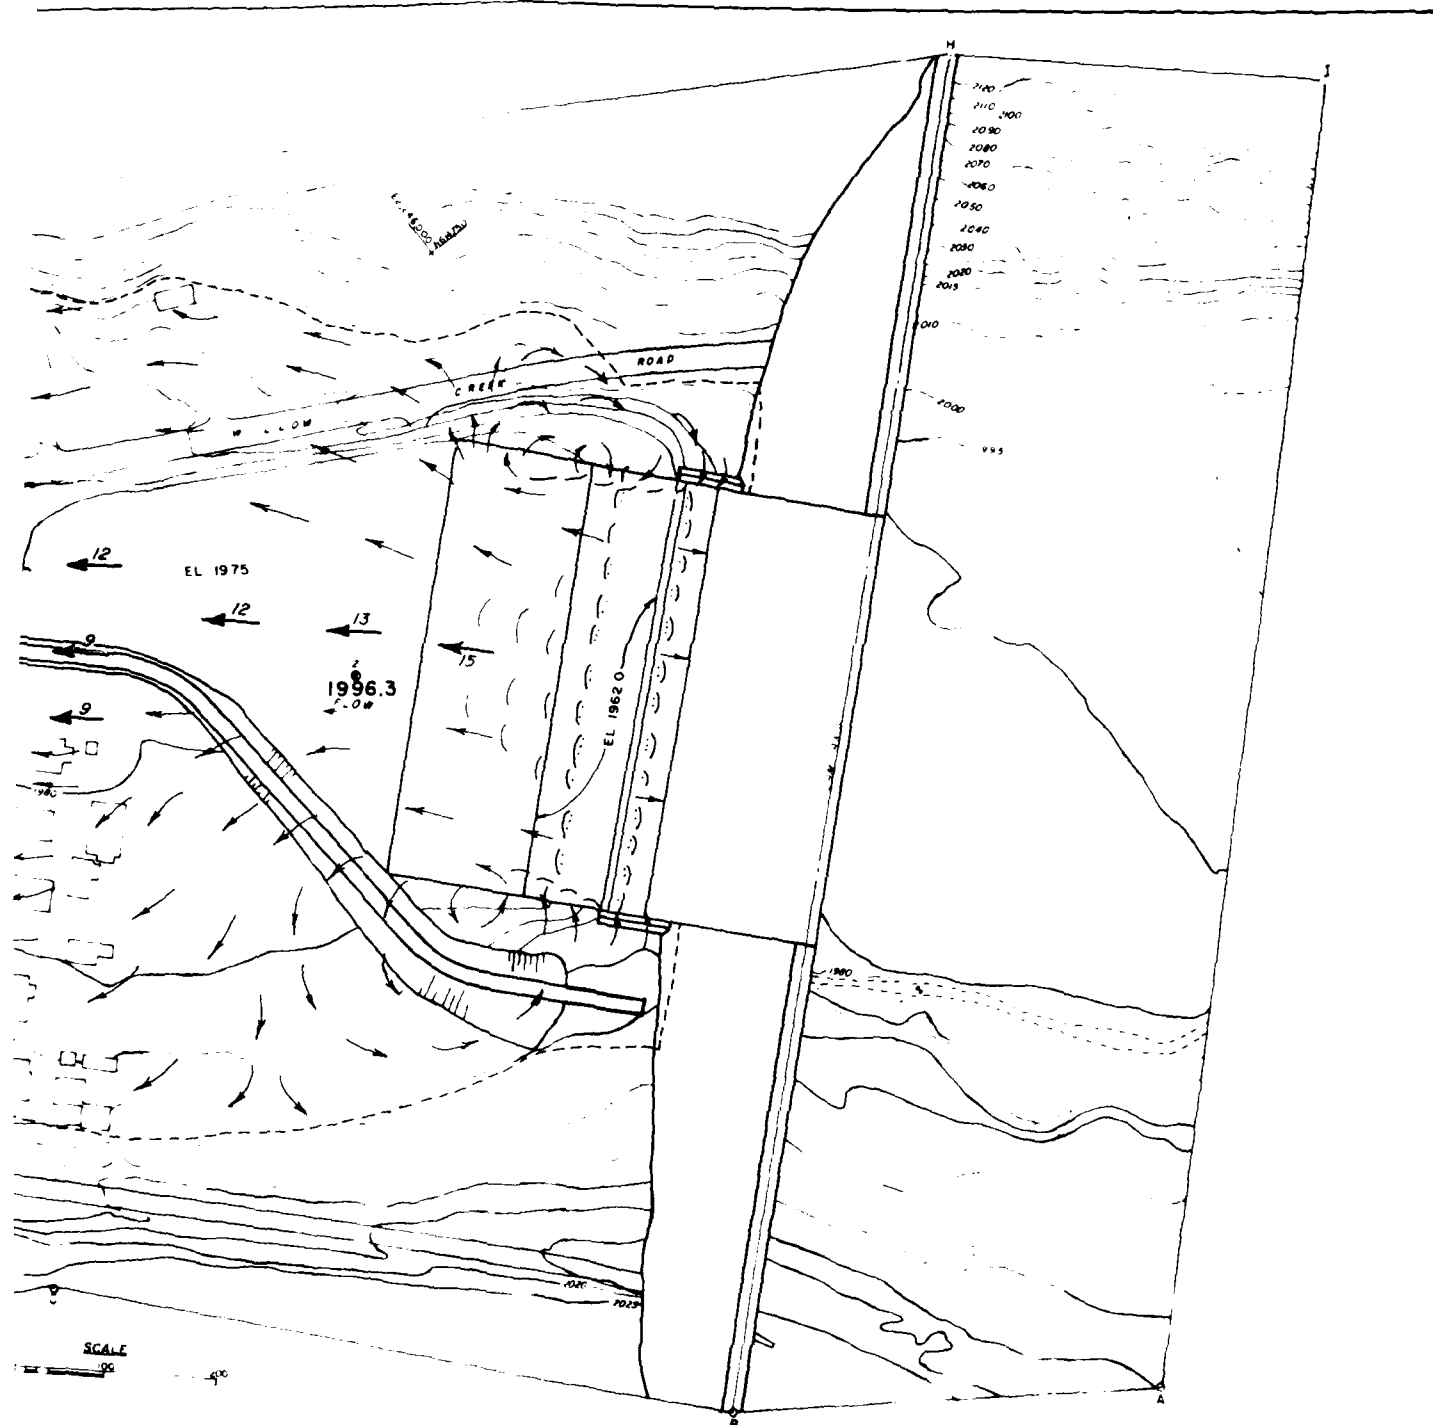
FLOW CONDITIONS
 REGULATED SPILLWAY DESIGN FLOOD
 DISCHARGE 91 700 CFS

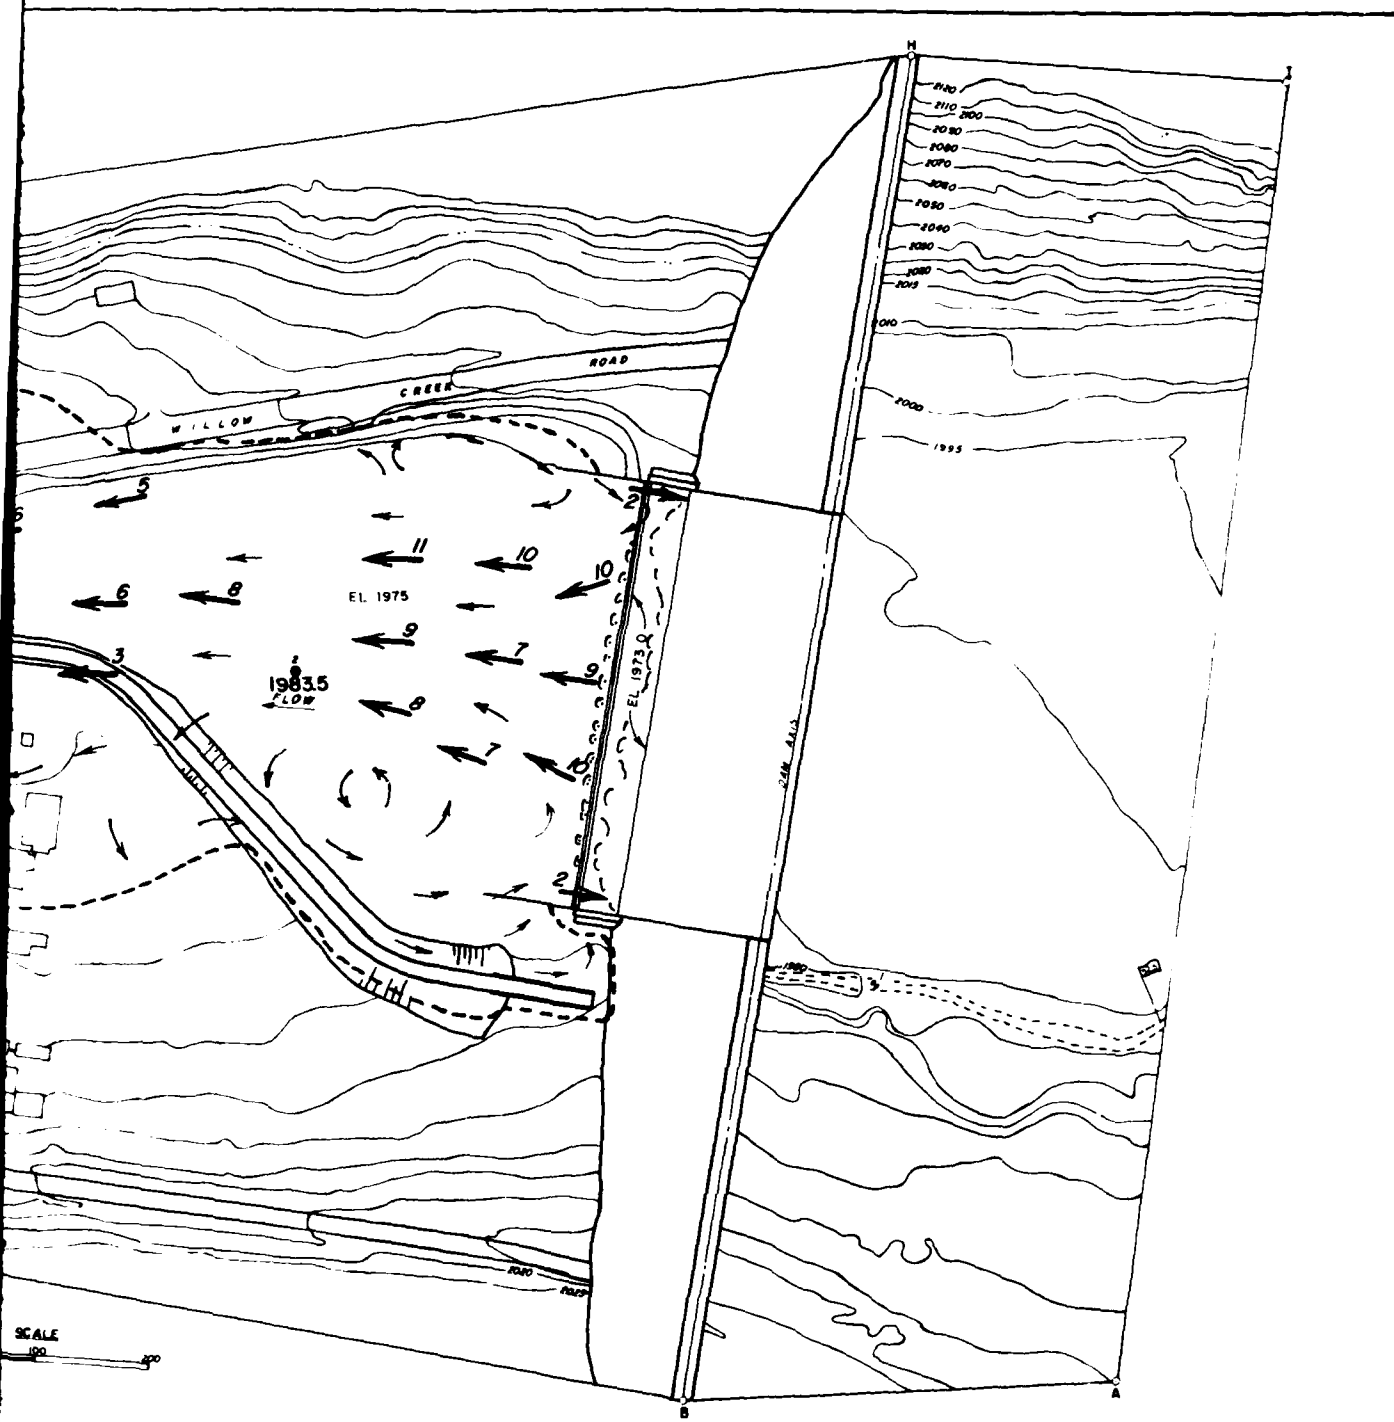
- ← 6 VELOCITY 3 FT ABOVE BOTTOM IN FPS
- SURFACE FLOW DIRECTION
- - - WATER'S EDGE
- 1983.5 WATER-SURFACE ELEVATION IN FEET

**FLOW CONDITIONS
REGULATED STANDARD PROJECT FLOOD
DISCHARGE 11 700 CFS**

STILLING BASIN FOR 11 700 CFS WITH SCOUR

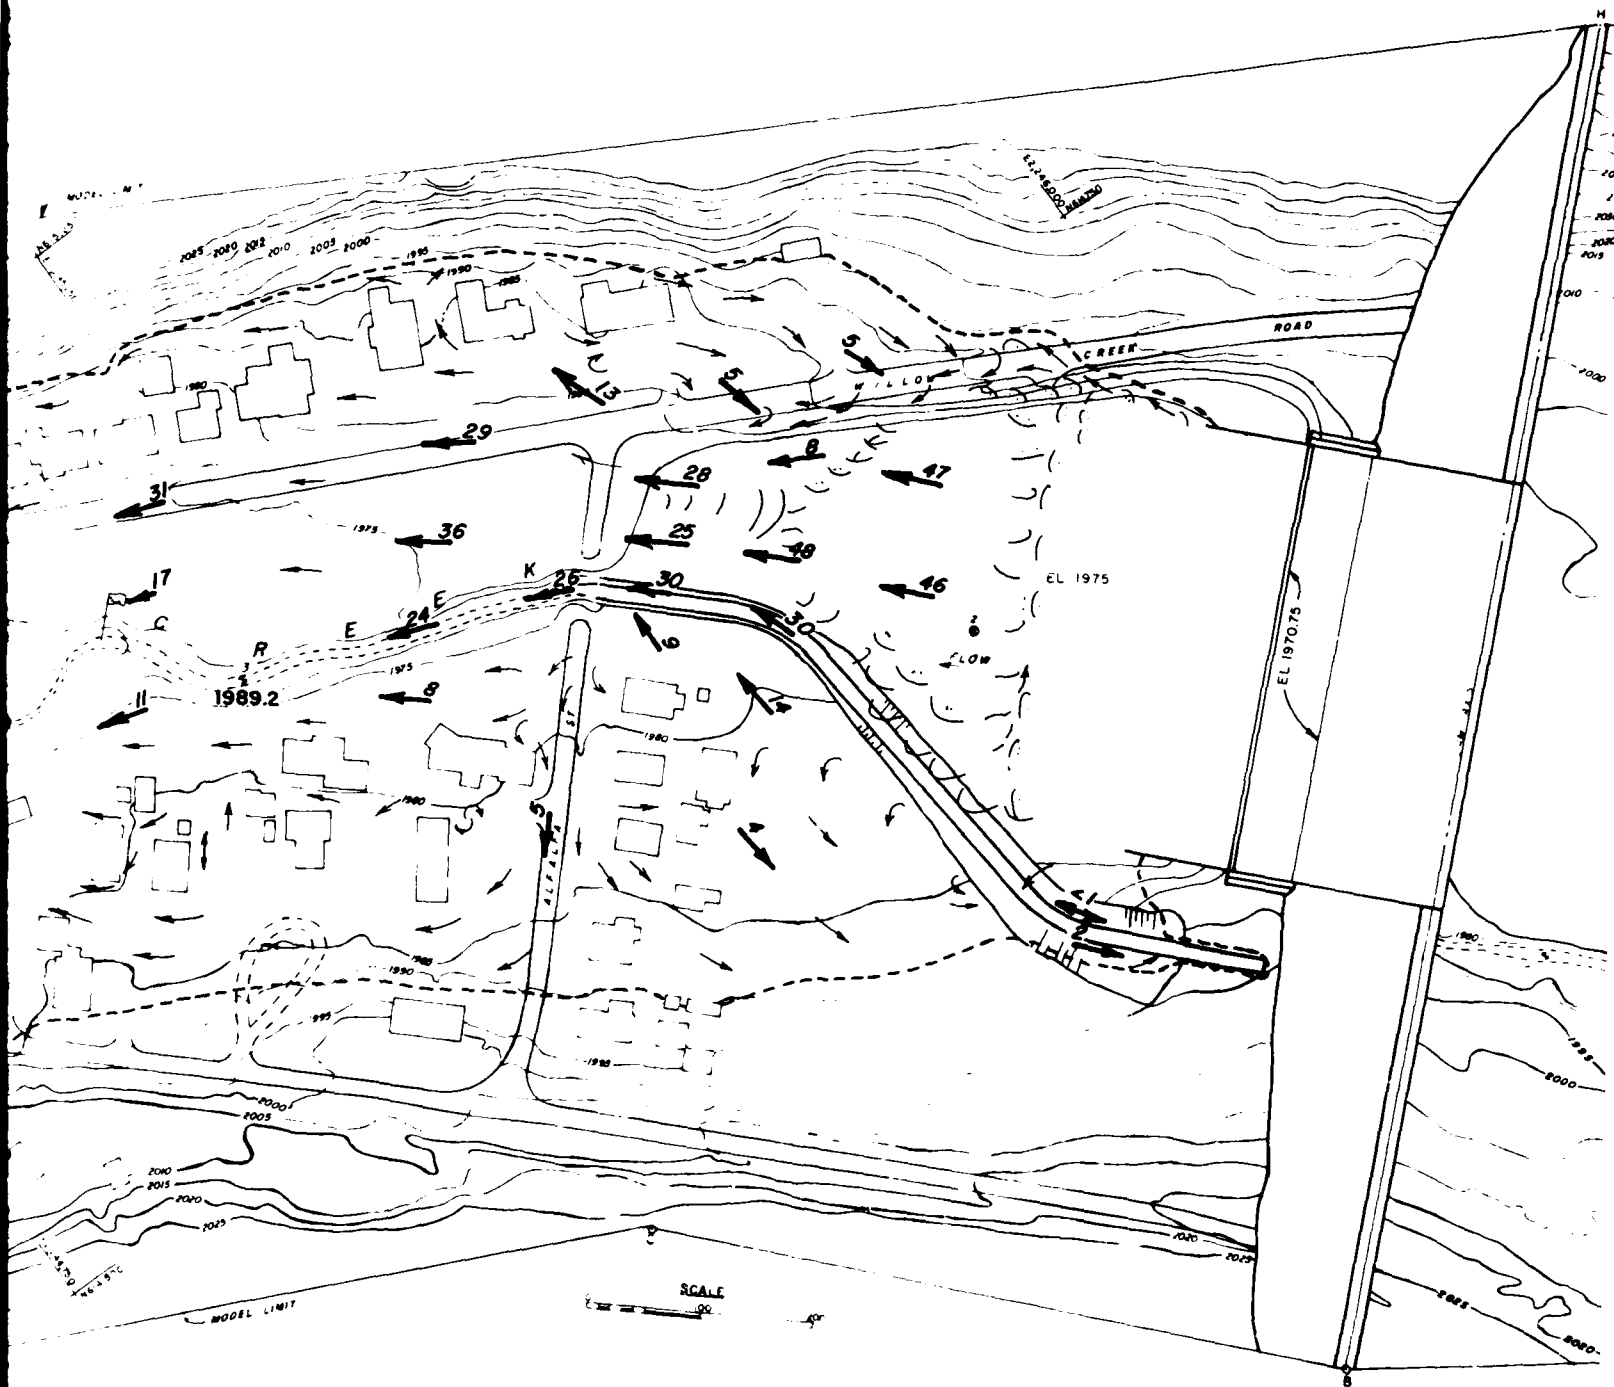
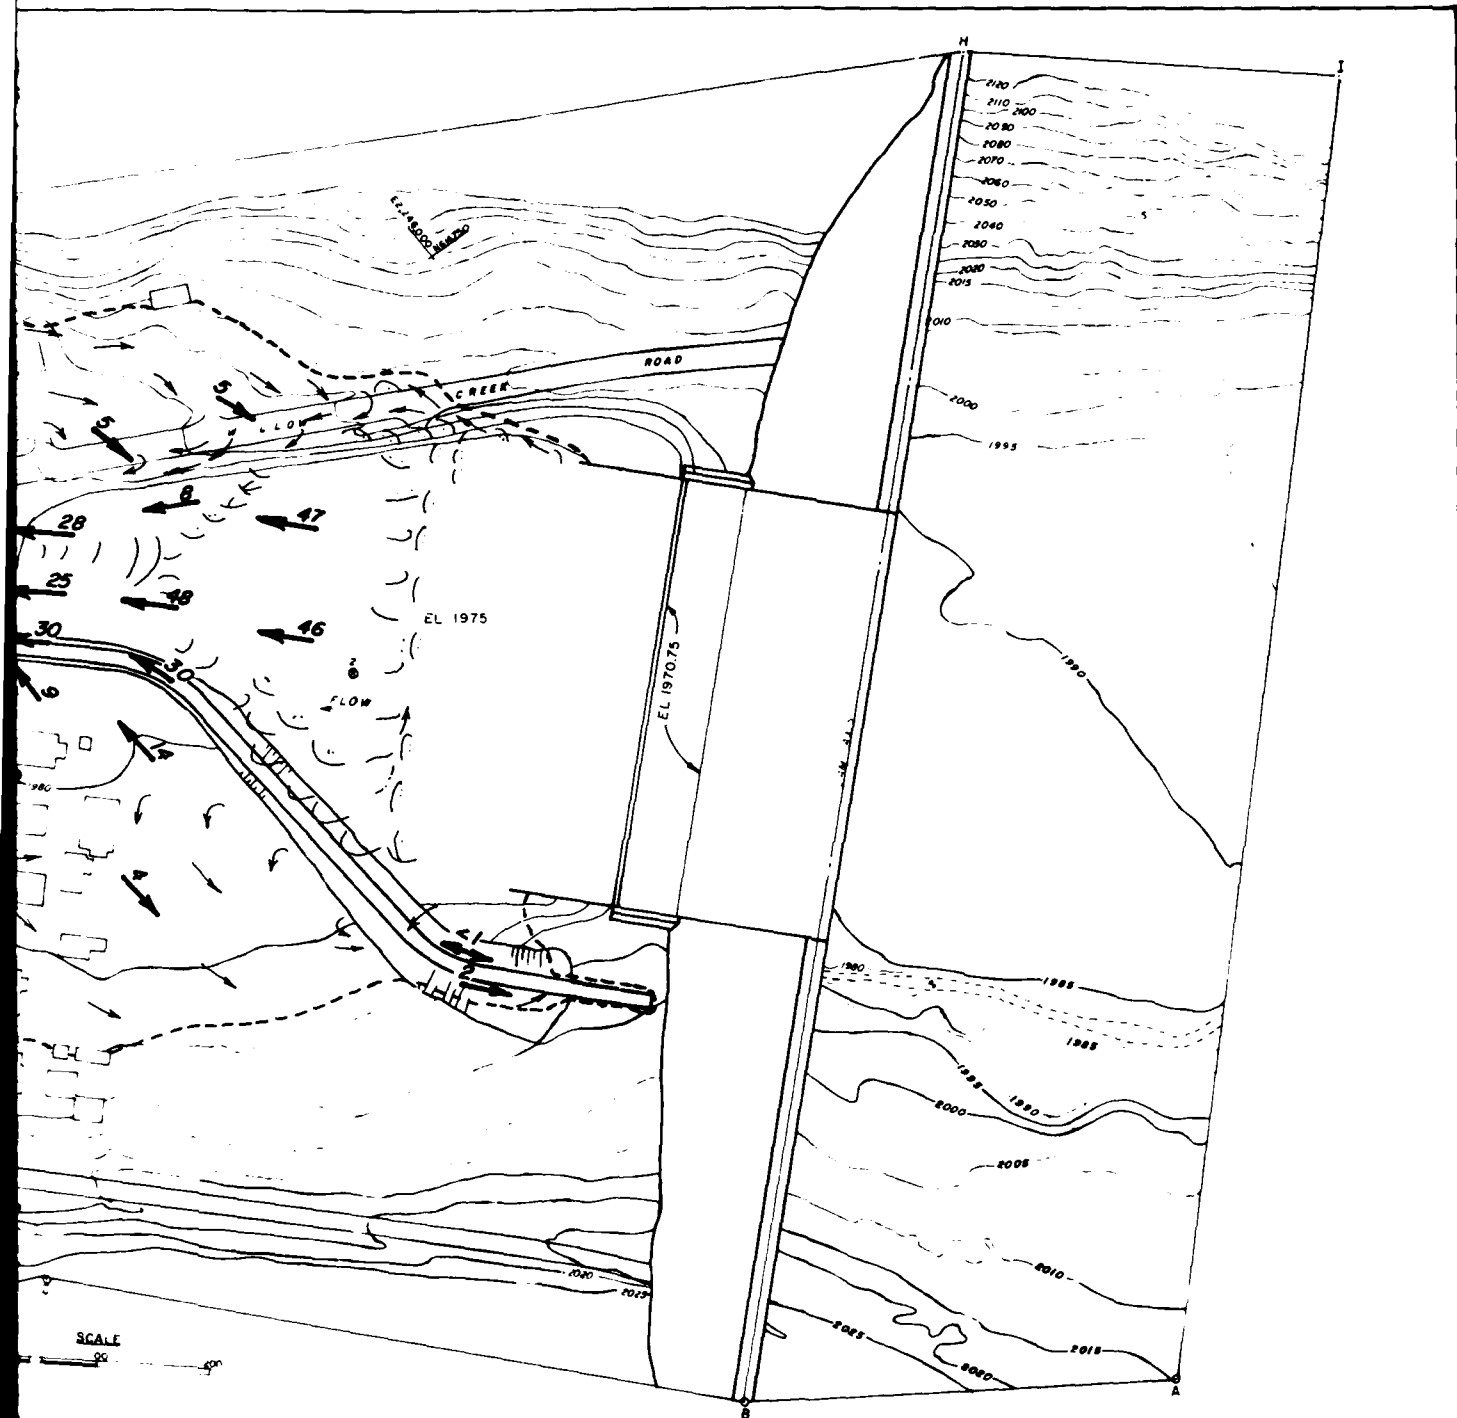
FLOW CONDITIONS REGULATED SPILLWAY DESIGN FLOOD

STILLING BASIN FOR 18000 CFS WITH SCOUR

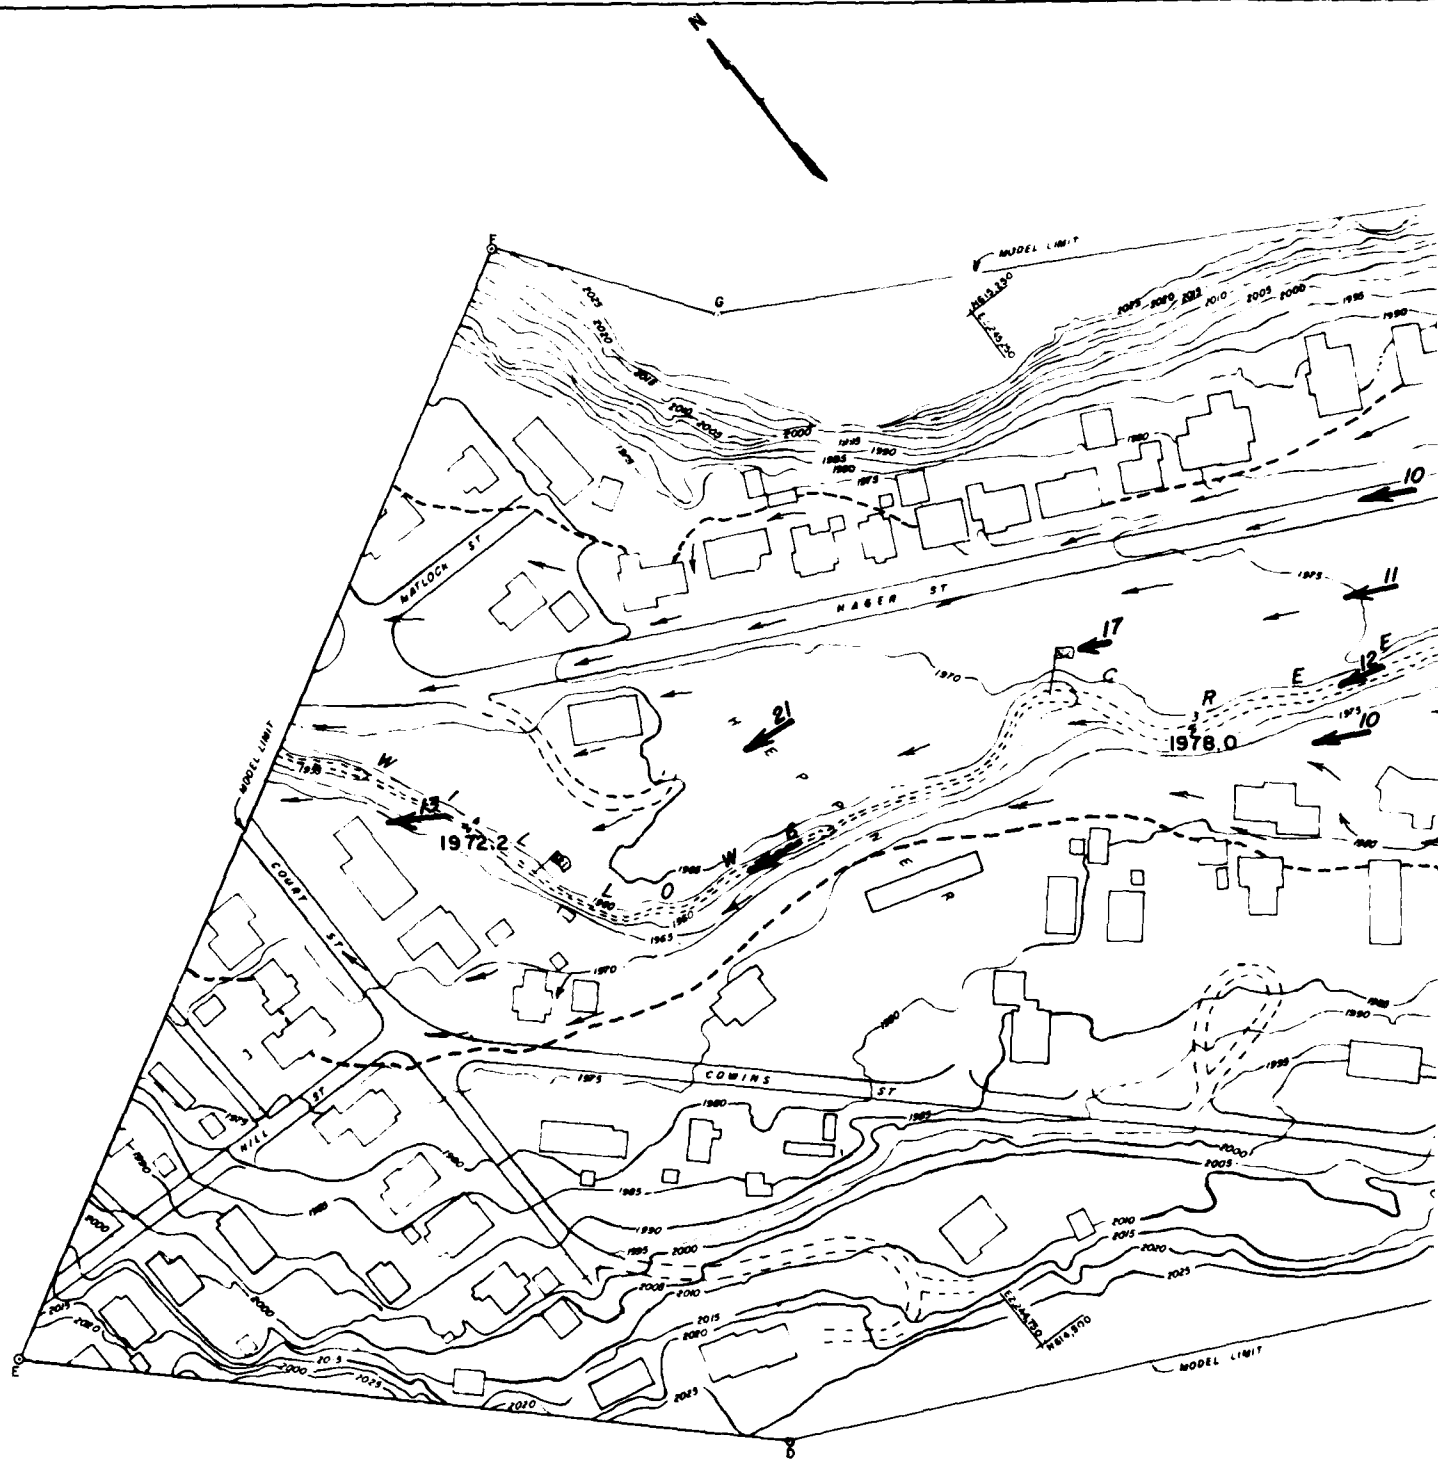
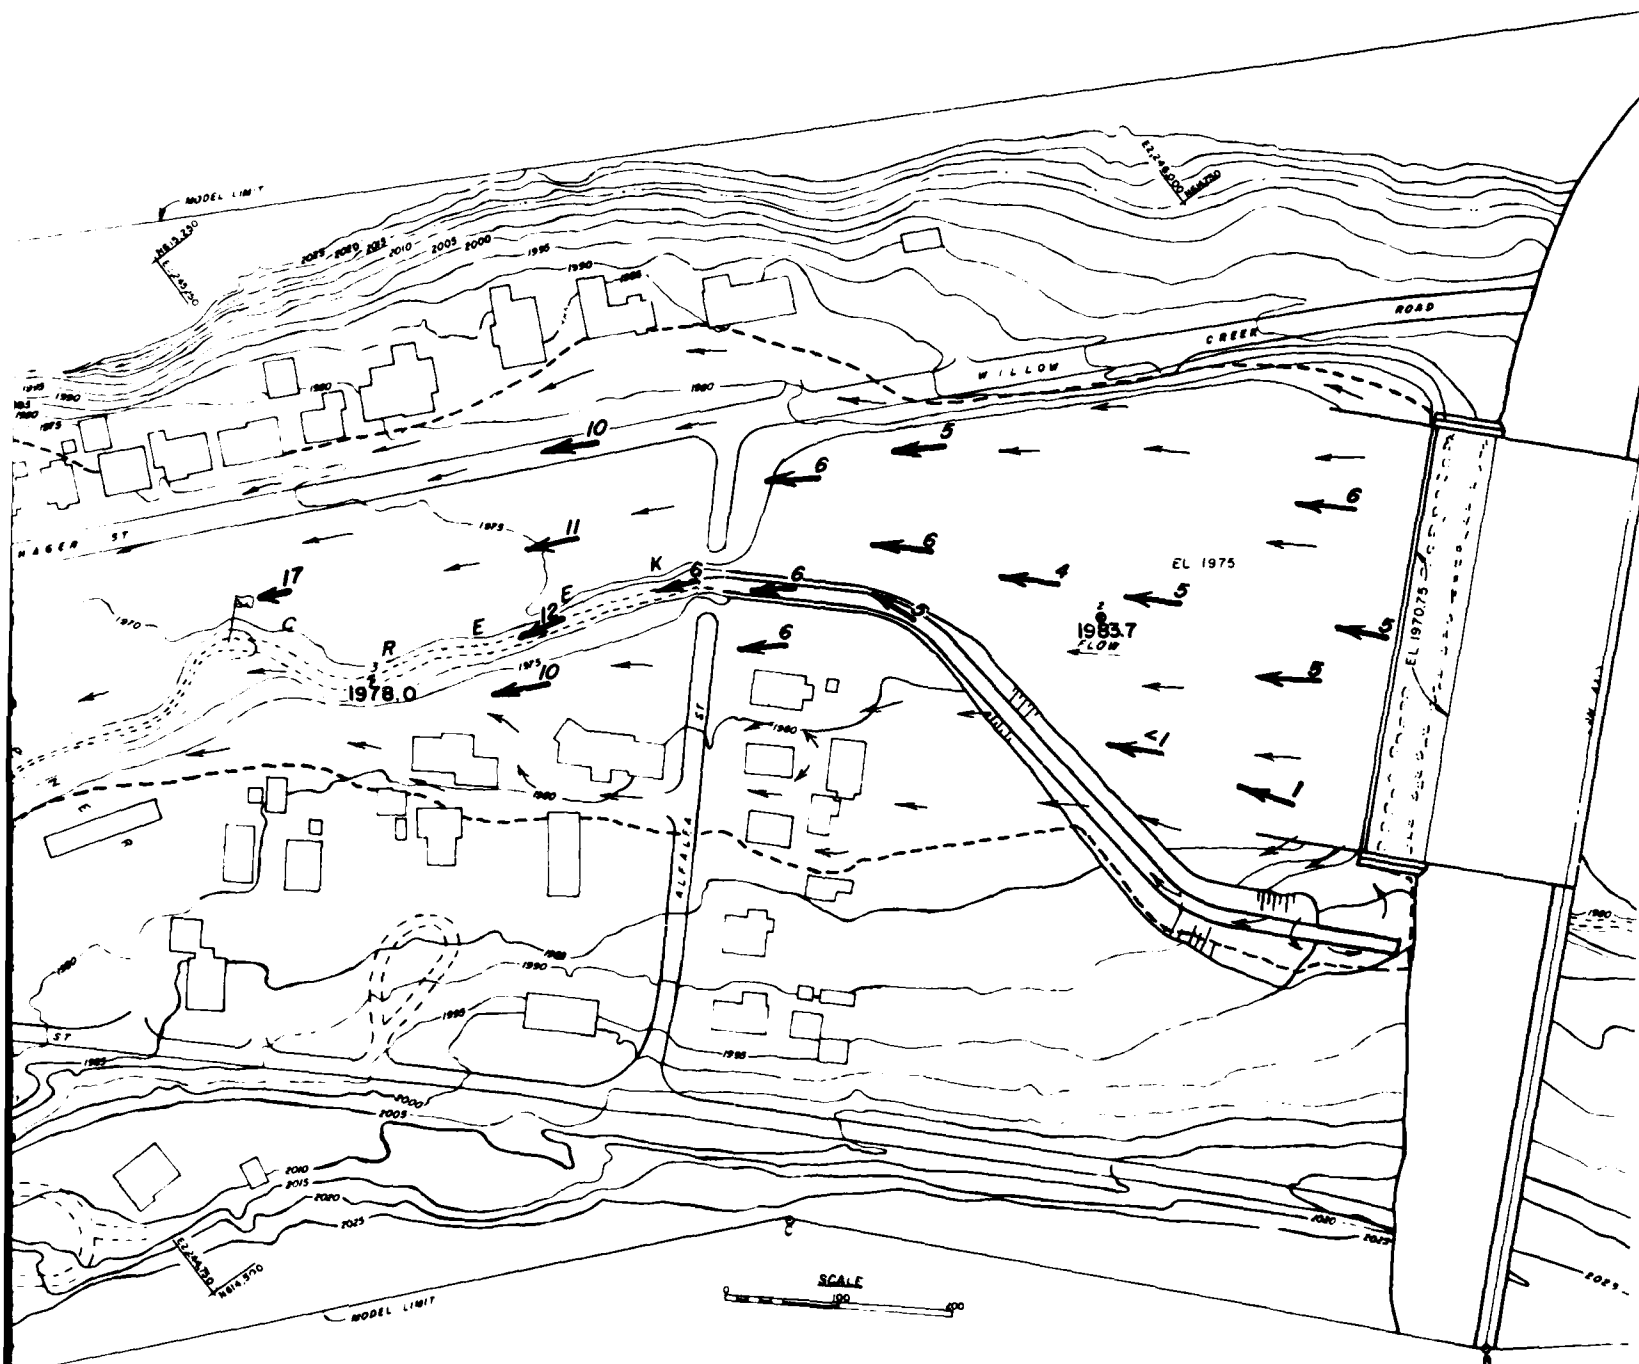
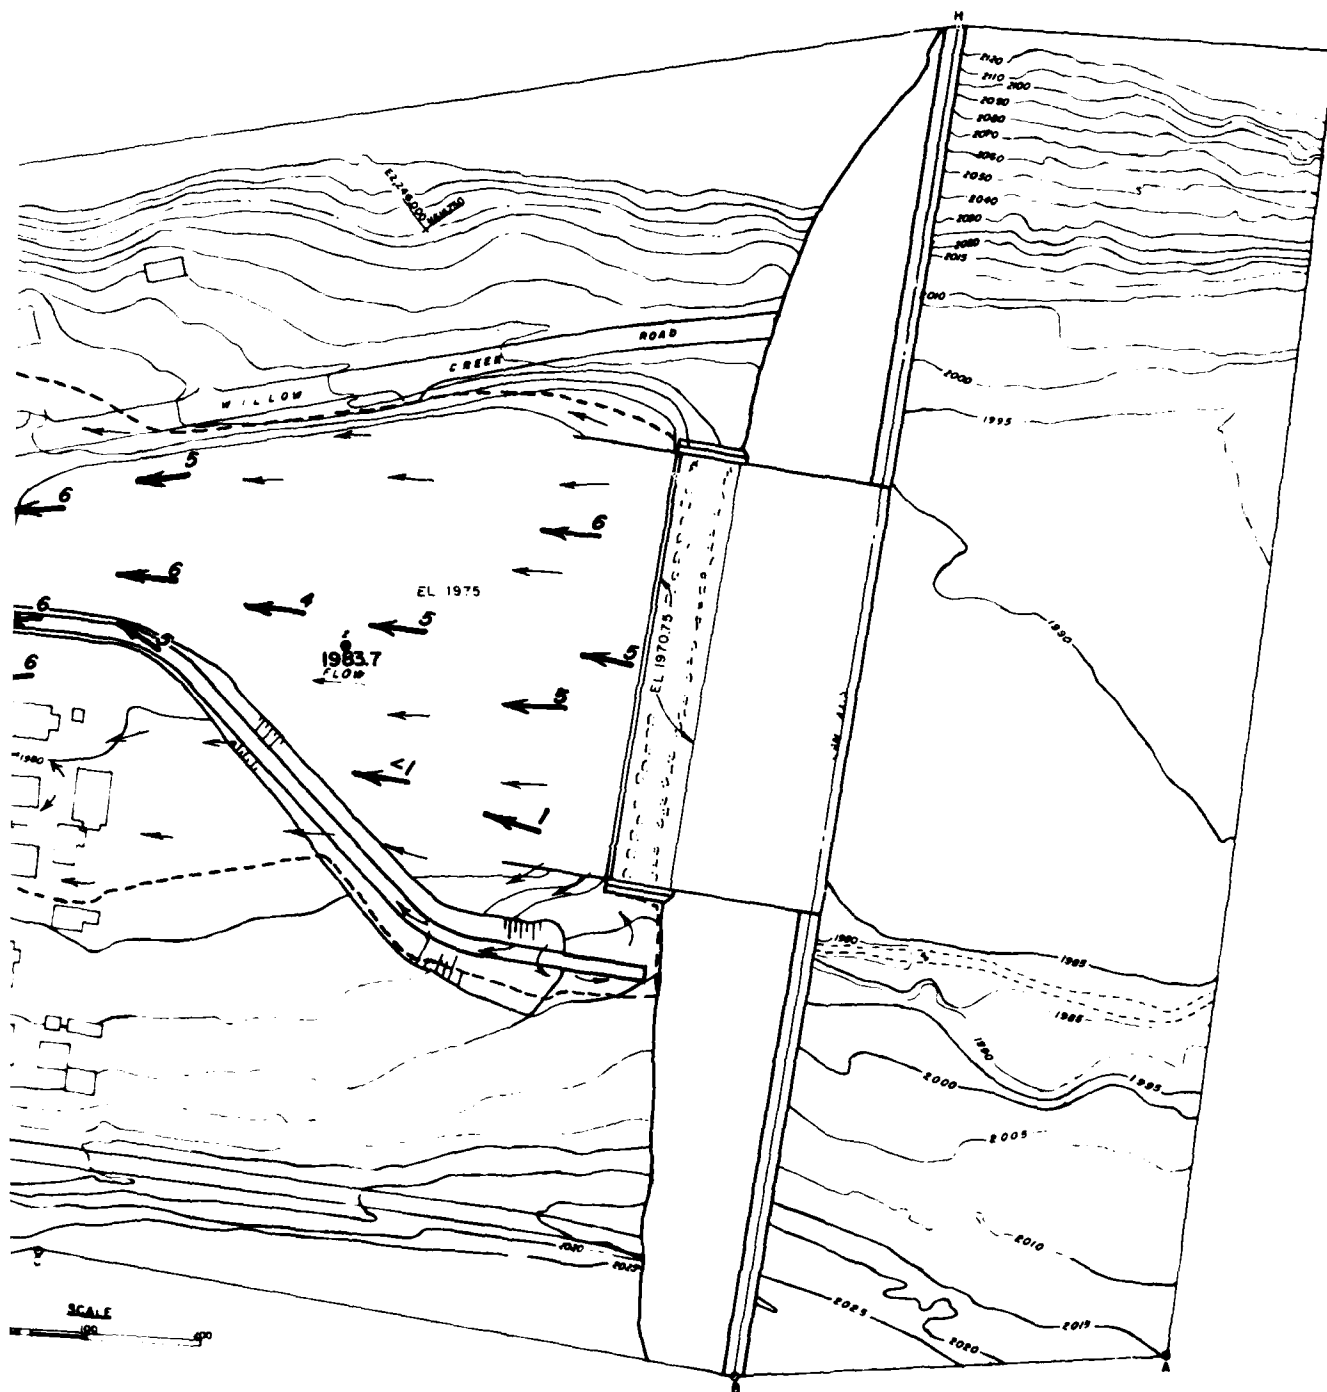
FLOW CONDITIONS
REGULATED STANDARD PROJECT FLOOD
 DISCHARGE 11 700 CFS
 STILLING BASIN FOR 18000 CFS WITH SCOUR

13. With the basin design discharge of 11,700 cfs, a good hydraulic jump formed totally within the basin (photograph 10). Velocities were 10 fps just downstream from the end sill, 6 fps at the washed out Alfalfa Street bridge, and 12 fps in the creek approximately 100 feet farther downstream (photograph 11 and plate 6). With 15,000 cfs the jump began to sweep out of the basin (photograph 12), and velocities were 11 fps downstream from the sweepout, 6 fps at the bridge, and 14 fps 100 feet beyond the bridge. A flow of 45,000 cfs caused a complete sweepout of the basin (photograph 13) and velocities of 19, 14, and 21 fps at the locations previously noted. The regulated spillway design flood of 91,700 cfs was flipped from the basin for about 200 feet downstream and created velocities of 49 fps upstream from Alfalfa Street, 28 fps at the bridge, and 37 fps 100 feet farther downstream (photographs 14 and plate 7). Depth in the creek near the downstream end of the test area (gage 4) was 2.3 feet lower than with the same unregulated flood. Flooding downstream from Alfalfa Street with the spillway design flood is shown in photograph 15.
